Manhole Inspection Summary

Manhole # S23K__016MH

Insp Date: **6/12/08 12:11 PM**

Location Address: **1400 Kuper St**

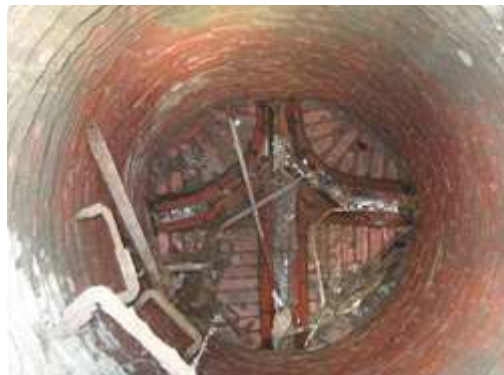
Top View

minor debris on bench as well in between rungs

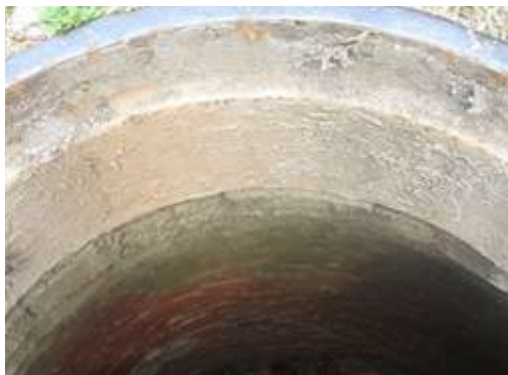
Miscellaneous

lid-frame infiltration (Chimney)

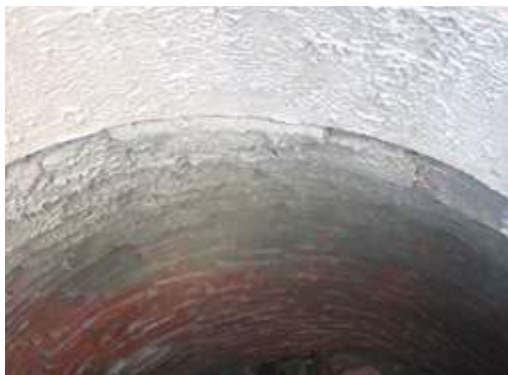
Defect 2

infiltration frame-chimney as well as lid-frame

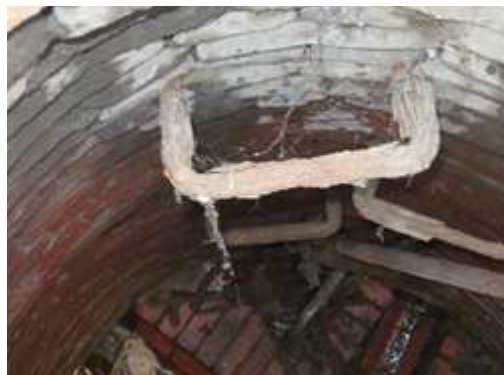
Defect 1

corroded rungs, evidence of corbel infiltration

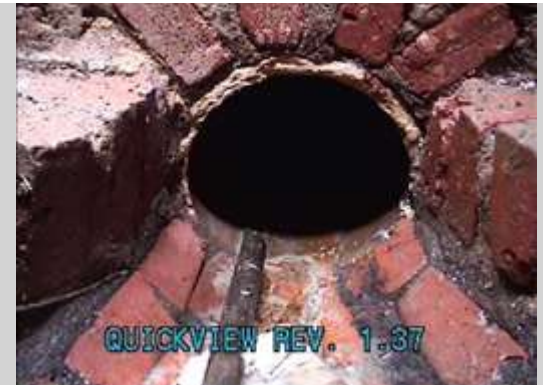
12 O'Clock Outflow

Pipe Height: **8.4** (in.) Rod and Bar (Angled)
Pipe Material: **Clay** ☐ Pipe Lined
Invert Depth: **8.59** (ft.) Flow Characteristics: **Slow**
Deposits: ☒ None ☐ Mud ☐ Sludge ☐ Debris ☐ Grease
Silt Depth: **0** (in.) Deposits Extent:
Infiltration: **None** Pipe Seal Cond: **Sound**

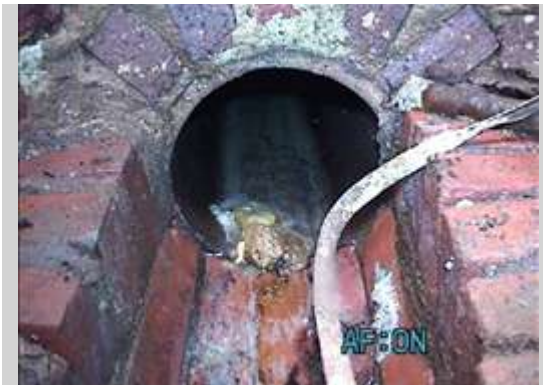
3 O'Clock Inflow

Pipe Height: **8.4** (in.) Rod and Bar (Angled)
Pipe Material: **Clay** ☐ Pipe Lined
Invert Depth: **8.09** (ft.) Flow Characteristics: **None**
Deposits: ☒ None ☐ Mud ☐ Sludge ☐ Debris ☐ Grease
Silt Depth: **0** (in.) Deposits Extent:
Infiltration: **None** Pipe Seal Cond: **Sound**

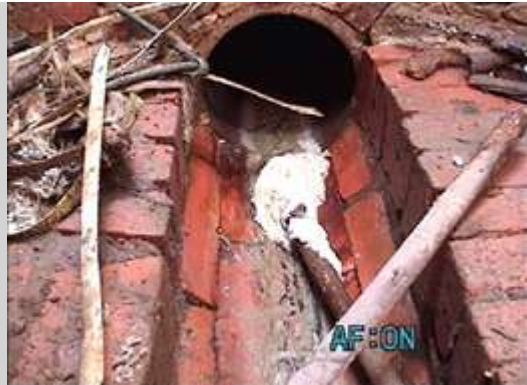
6 O'Clock Inflow

Pipe Height: **8.4** (in.) Rod and Bar (Angled)

Infiltration: **None** Pipe Seal Cond: **Sound**

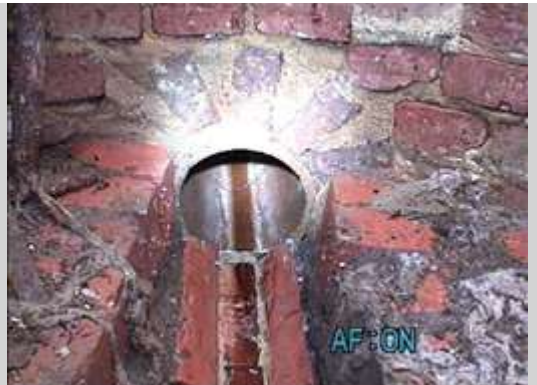
9 O'Clock Inflow

Pipe Height: **6** (in.) Rod and Bar (Angled)

Infiltration: **None** Pipe Seal Cond: **Sound**
